Aspen Home Inspections

SUMMARY REPORT

Client: Happy Customer
Inspection Address: Forest Highlands Lot 221, Flagstaff, AZ 86001
Inspection Date: 5/5/2011 Start: 10:00 am End: 2:00 pm
Inspected by: Scott Hartfield

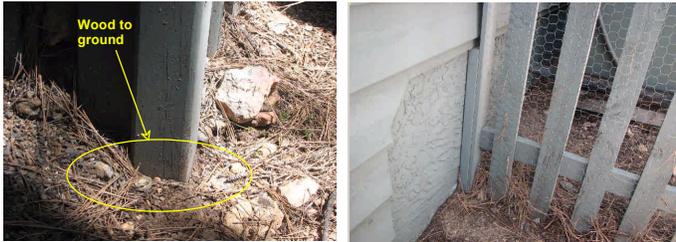
The fence at the rear of the structure contains wood to ground. We recommend service.

The fence at the rear of the structure contains wood to ground - *Continued*
